OK FOODS - PLANT 1 RENOVATION

by: Donald L. Yates, P.E.

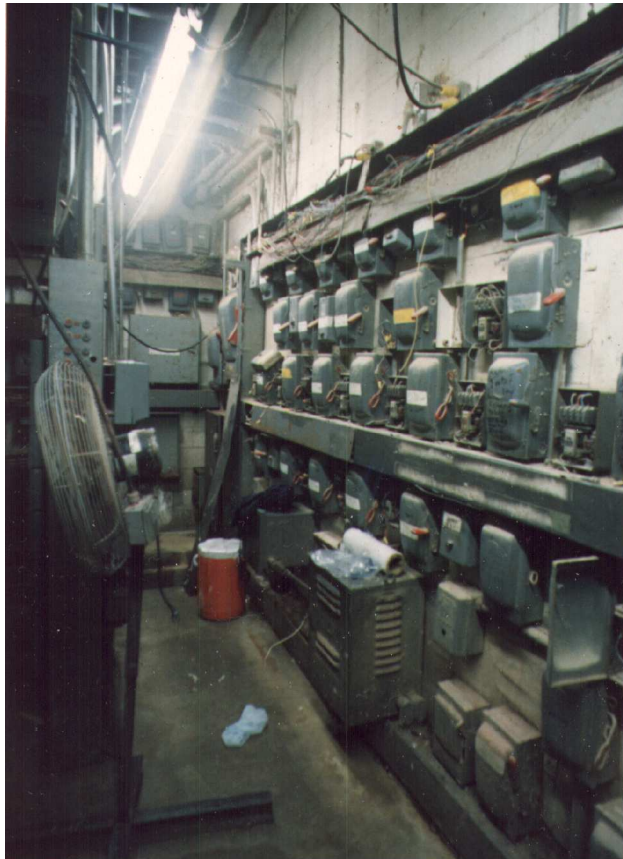
Figure 1 - Existing Electric Room

the operation of the electrical system. The facility also had some severe safety hazards, such as a mostly abandoned electrical room located above the maintenance area. This electrical room had equipment on all four walls, with wires protruding from wireways and open switches. Most of this equipment was abandoned, but some did still feed active loads.

With the field investigation well under way, it was now possible to start making design decisions. Mr. Yates, working closely with Mr. Saulsberry and Mr. King, decided that a new electric room would be built adjacent to the maintenance room. A standard OK Foods arrangement, 2-2500 KVA transformers, feeding 2-3000 amp switchboards, would be utilized to feed the plant. New underground primary would be installed to serve these transformers and also provide a looped underground feed to these transformers and one additional 2500 KVA transformer serving the Reed Lane facility. One of the main switchboards would be dedicated to the engine room load while the second switchboard would be used to serve the remainder of the plant load. Several motor control centers would be used to feed the various motors located throughout the facility and "Spectra" style panels would be used for other power loads.

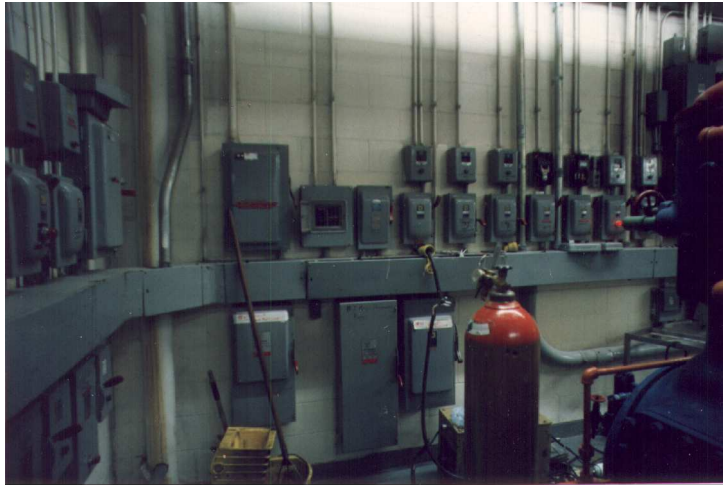
Figure 2 - Engine Room Before Renovation

The engine room presented the biggest challenges to design success (see photo #2). The area was fed from the 3750 KVA transformer into 2-600 amp switches. The individual loads were fed by tapping the load side conductors of these switches. These conductors were located along the wall in wireways. To minimize equipment down-time was a high priority in this area. The best way to achieve this requirement was to install two new motor control centers and several "Spectra" style panels. This would allow the Contractor to energize the new equipment and then transfer loads in an orderly manner.

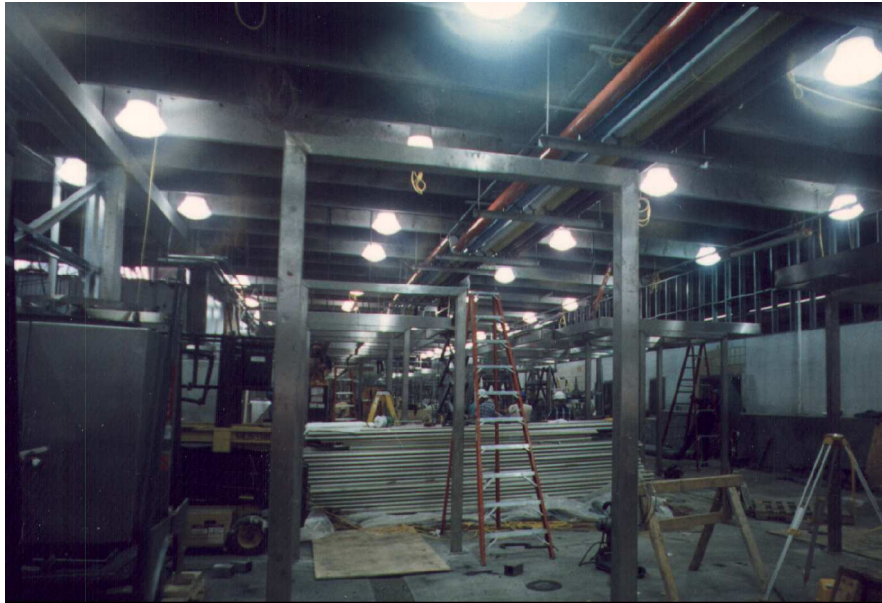
Figure 3 - Plant Interior During Construction

The design process was completed in approximately six weeks. Bieker Electric was sitting ready as the precast tees were set on the structure. Once a tee was anchored, Bieker's personnel were running conduits and hanging fixtures. They had already stubbed conduits out of various panels, through or over the existing structure, and to a location where it would join with the new structure. This enabled them to energize the new light fixtures and equipment very quickly.
